**NOTICE: PLEASE READ PRIOR TO INSTALLING FICM**

## Fuel Injection Control Module (FICM) Programming

## Wiring Harness Inspection

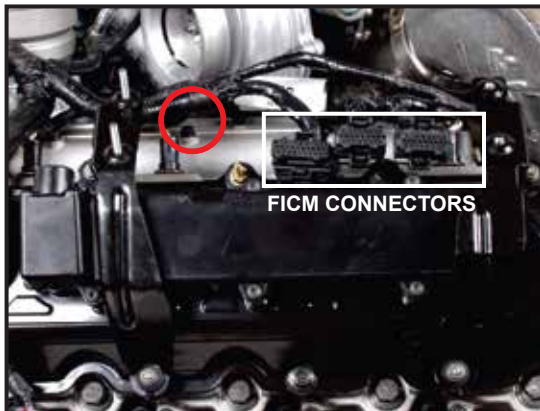
Check for wiring harness damage from contact with intake manifold bolts.

It is important to perform a thorough visual inspection for wiring chafing of the fuel injection harness. If chafing is discovered the fuel injection harness should be replaced. See the images below for common chafe locations and injection harness routing.

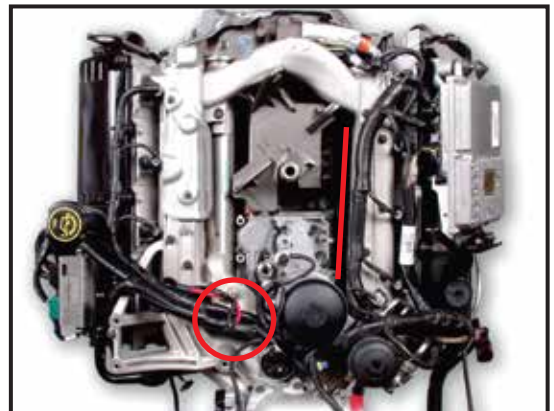
Early 2003 Production Harness Routing. Routed between oil filter housing and secondary fuel filter housing.

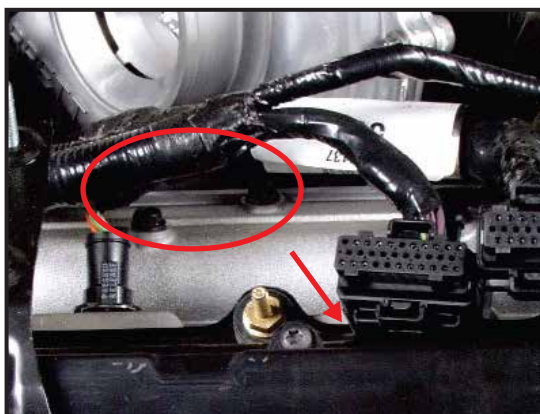
Check for chafing on the back side of the FICM connectors. The wires can contact the edge of the valve cover.

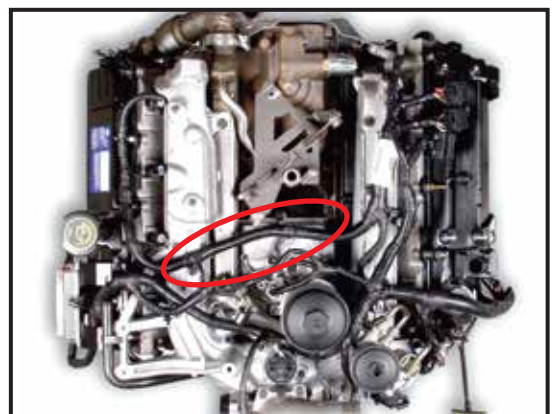
Late 2003, 2004+ Harness Routing. Routed between oil filter housing and compressor housing.
