About the Arctic PowerVolt FICM by GB Remanufacturing, Inc.

GB's Arctic PowerVolt FICM is a remanufactured high performance FICM designed to improve cold weather engine operation, improve injector response time and reduce injector stiction, a common issue on the Ford Powerstroke 6.0L. The APV FICM accomplishes this by increasing the voltage to the injectors from 48 volts to 58 volts and modifies the peak current used to activate the fuel injectors. Unlike some competitive 58 volt FICMs, the GB APV FICM upgrades all of the components and drivers exposed to this higher voltage. In addition to these upgrades, GB corrects many of the original design and manufacturing defects that are present in the original equipment FICMs. The result is a highly reliable unit that improves engine performance.

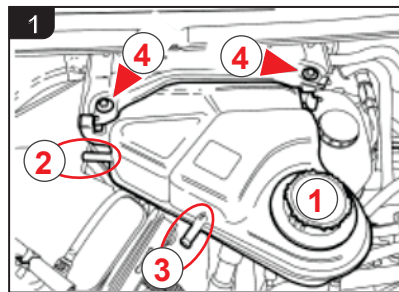
1. Figure 1: With the engine cool and at ambient air temperature, wrap a thick cloth around the top of the cap (1) of the degas bottle. Slowly loosen the cap. If pressure is present, stop and let the engine cool.

2. Figure 1: After cooling system has been relieved of pressure, remove the engine vent hose (2) and radiator vent hose (3) from the top of the degas bottle. Cap the two ports on the degas bottle and hoses to prevent coolant loss.

3. Figure 1: Remove the two bolts from the degas bottle (4). Slide the degas bottle aside.

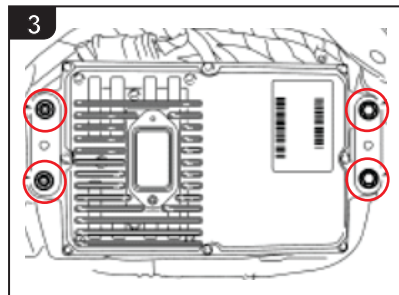
5. Figure 3: Remove the four retaining bolts holding the FICM in place.

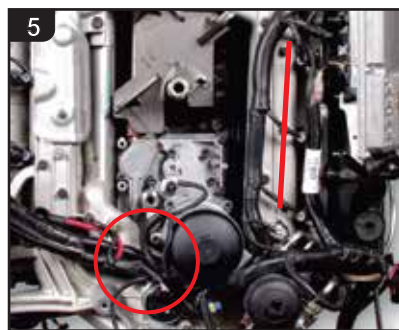
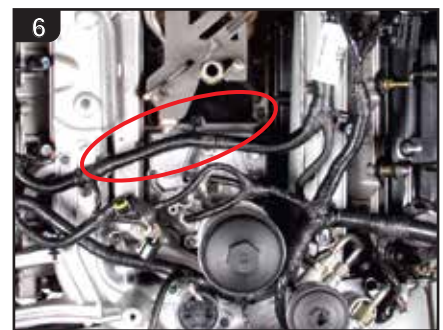
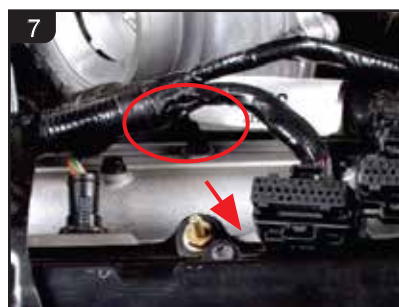
8. WIRING HARNESS INSPECTION - Figures 5-7: A common area of concern with the 6.0L is chafing of the fuel injection harness. Wire chafing can occur between the fuel injection wiring harness and the valve covers, intake manifold and intake manifold mounting bolts. This can result in intermittent poor operating conditions that are difficult to diagnose. Using the images in figures 5-8 carefully inspect the wiring harness and engine contact points shown in red. Any damage to the harness must be corrected BEFORE the GB APV is installed.

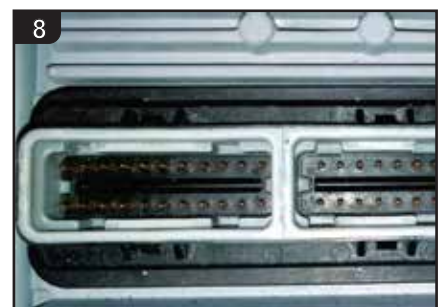
9. INSPECT PINS ON THE FICM BEING REMOVED - Figure 8: A common area of failure on the FICM is burnt pins on the 22 pin connector, this is the largest connector of the three. Inspect the FICM being REMOVED for burnt pins. If the pins are burnt it is likely the connector on the injection harness has burnt pin sockets. If not corrected, this will result in damage to the GB APV being installed, which is not covered by GB's limited warranty. Replace any burnt socket pins inside the connector plug prior to installation.

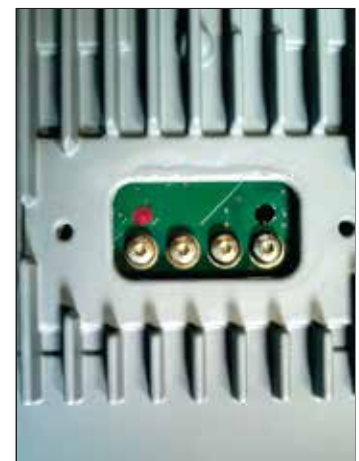
Procedure A - Verify 58 Volt Operation (Optional)

Although optional, you may want to verify 58 volt operation by taking a direct measurement at the back of the FICM using a multi-meter.

1. With the engine off, remove the two screws securing the access cover on the back side of the FICM (opposite side of the connectors). **DO NOT REMOVE THE SCREWS ON THE FRONT OF THE FICM AS THIS WILL VOID THE WARRANTY.**
2. Turn the key on but do not start the engine.
3. Using a digital multi-meter in DC voltage measurement mode, place the black lead on the screw with the black dot and the red lead on the screw with the red dot. Voltage should be 58 volts (+/- 4). **USE CAUTION NOT TO TOUCH RED METER LEAD TO FICM CASE, DOING SO WILL PERMANENTLY DAMAGE FICM.**
4. Reinstall the access cover ensuring the screws are tight. Failure to tighten cover may result in water intrusion and damage to FICM.

Because the FICM monitors and communicates the voltage supplied to the injectors to the PCM, the 58 volts would be perceived by the PCM as being too high, this would normally result in a diagnostic code P0611 (FICM Performance Failure). Because of this, the FICM has been re-calibrated to transmit 48 volts to the PCM when in fact the voltage to the injectors is 58 volts. This ensures that the self diagnostic capabilities for the FICM and PCM remain intact. If you monitor the "FICM_MPWR" voltage parameter via a scan tool you will see 48 volts. If you would like to verify the FICM is actually delivering 58 volts, you may do so by measuring the injector voltage at the back of the FICM using procedure A on the back side of this document.
